NBSIR 74-467

Simulated Solar Heat Tests on M.U.S.T. Air-Inflatable, Double-Wall Hospital Ward Shelters

Final Report

Prepared for
United States Army Natick Laboratories
Shelters Branch
Natick, Massachusetts 01760

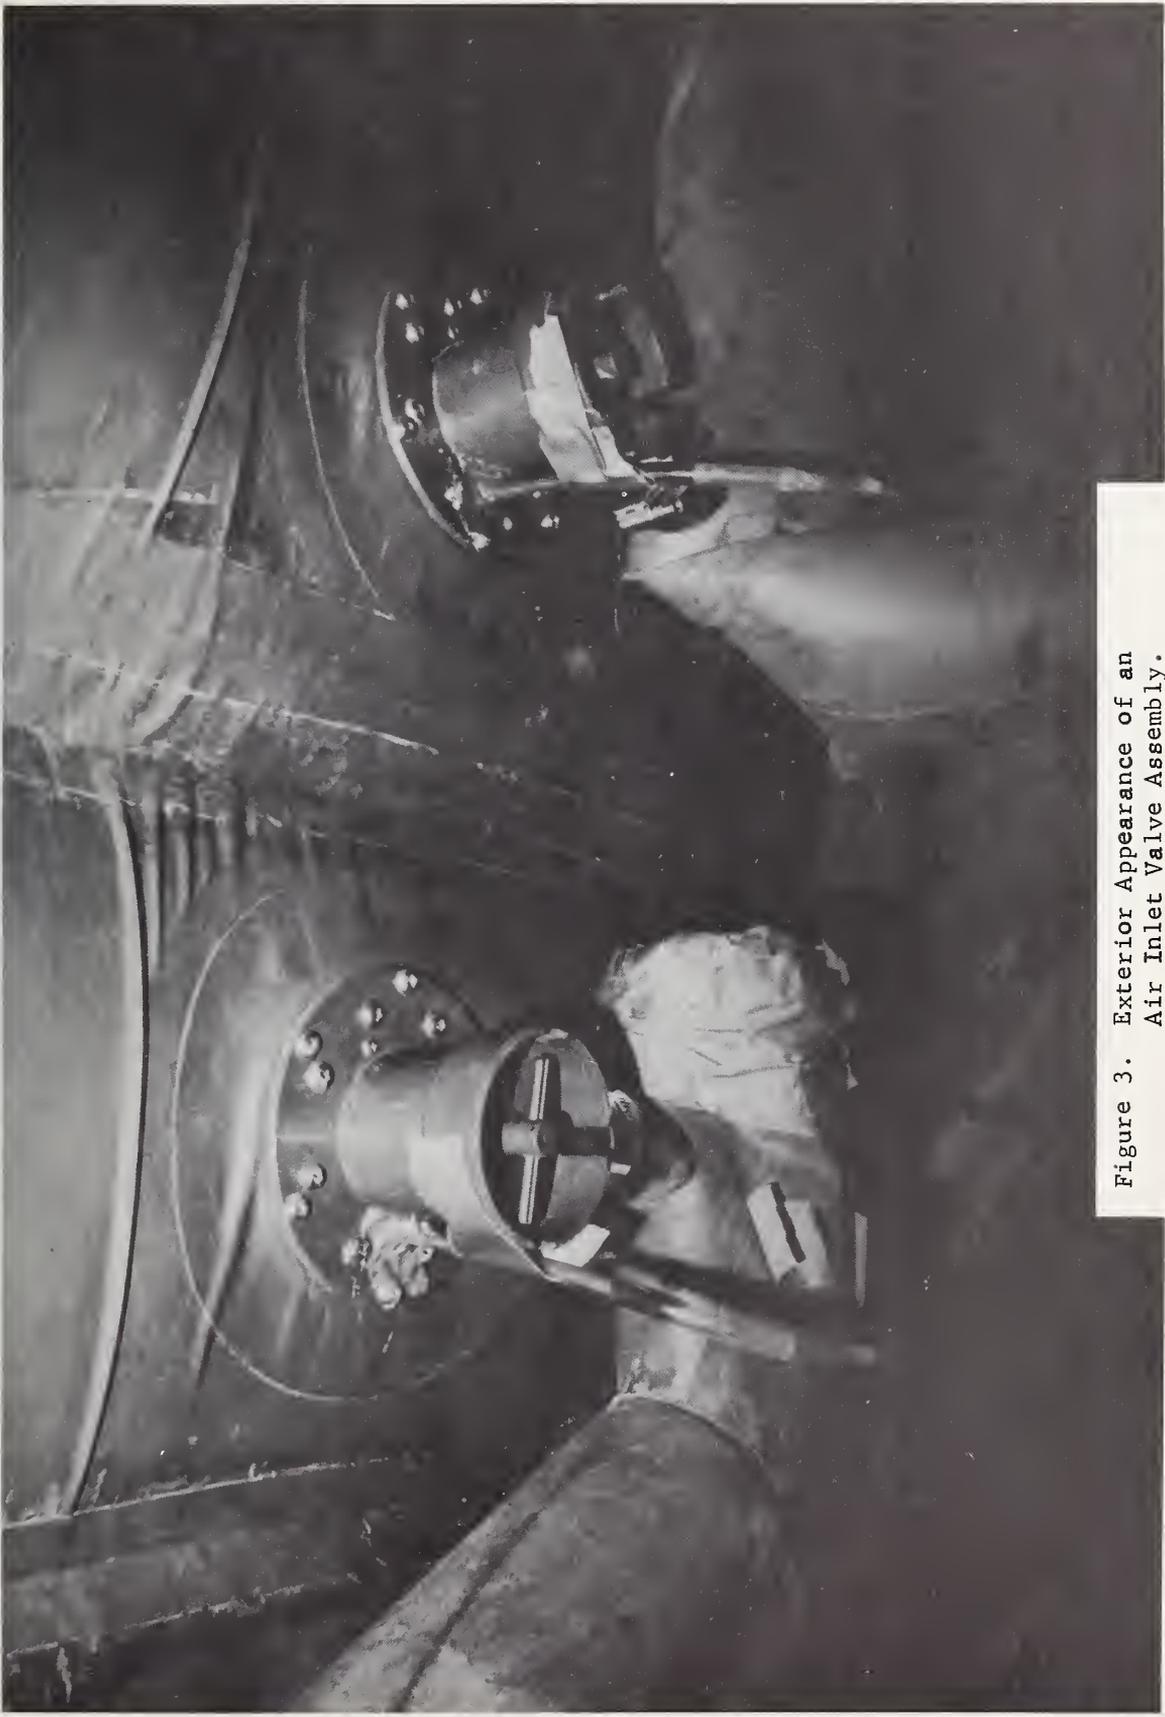
Manometers were used to provide a continuous measure of the air pressure in each air inflatable bladder. The manometer installation consisted of drilling a small hole through the air inlet valve assembly, inserting a plastic tube in the hole, and connecting the plastic tube to manometer gauges. The plastic tube, as inserted in the air inlet valve, can be observed in figure 3.

Figure 3. Exterior Appearance of an Air Inlet Valve Assembly.

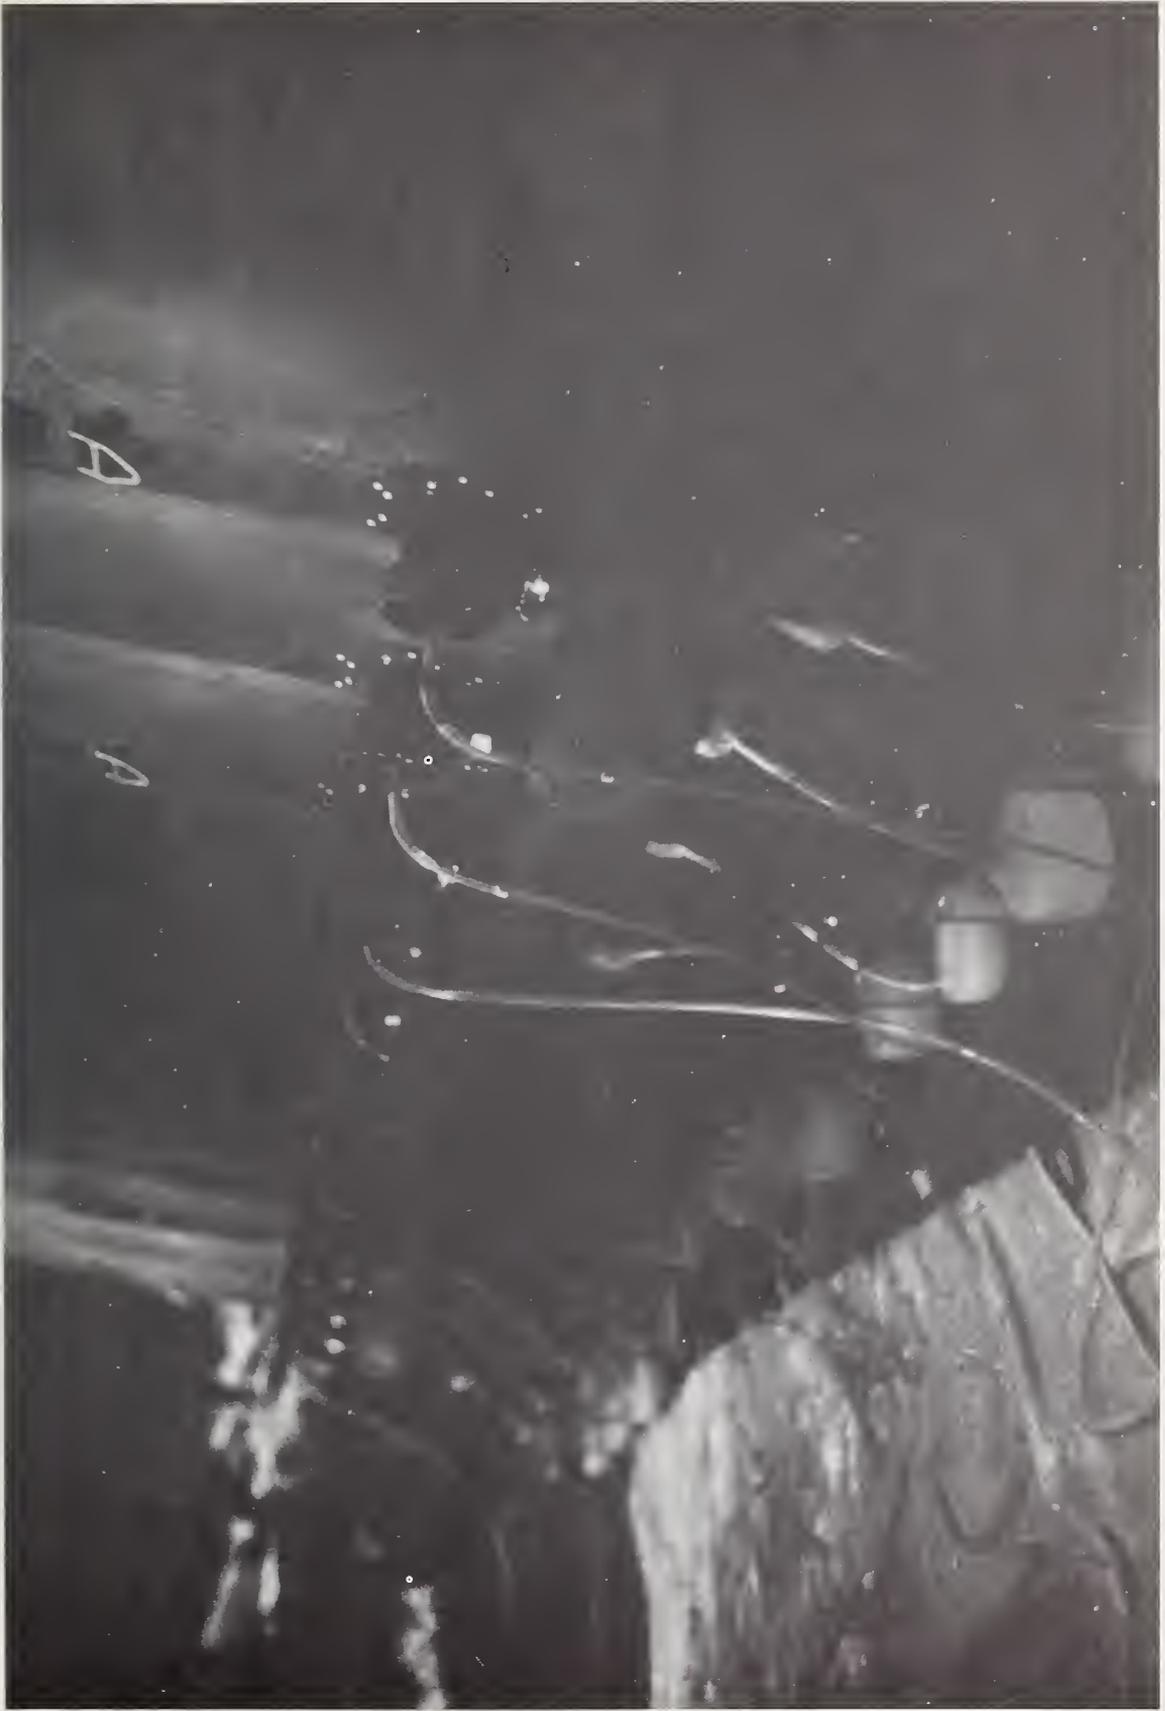
Selected pressure relief valves, which were included on each air inflatable chamber, were monitored during the tests of all shelters. The relief valves were designed to function at 1.75 ± 0.25 psi. Figure 7 shows the monitors for the pressure relief valves of Shelter section F-2.

Figure 7. Pressure Relief Valve Monitors

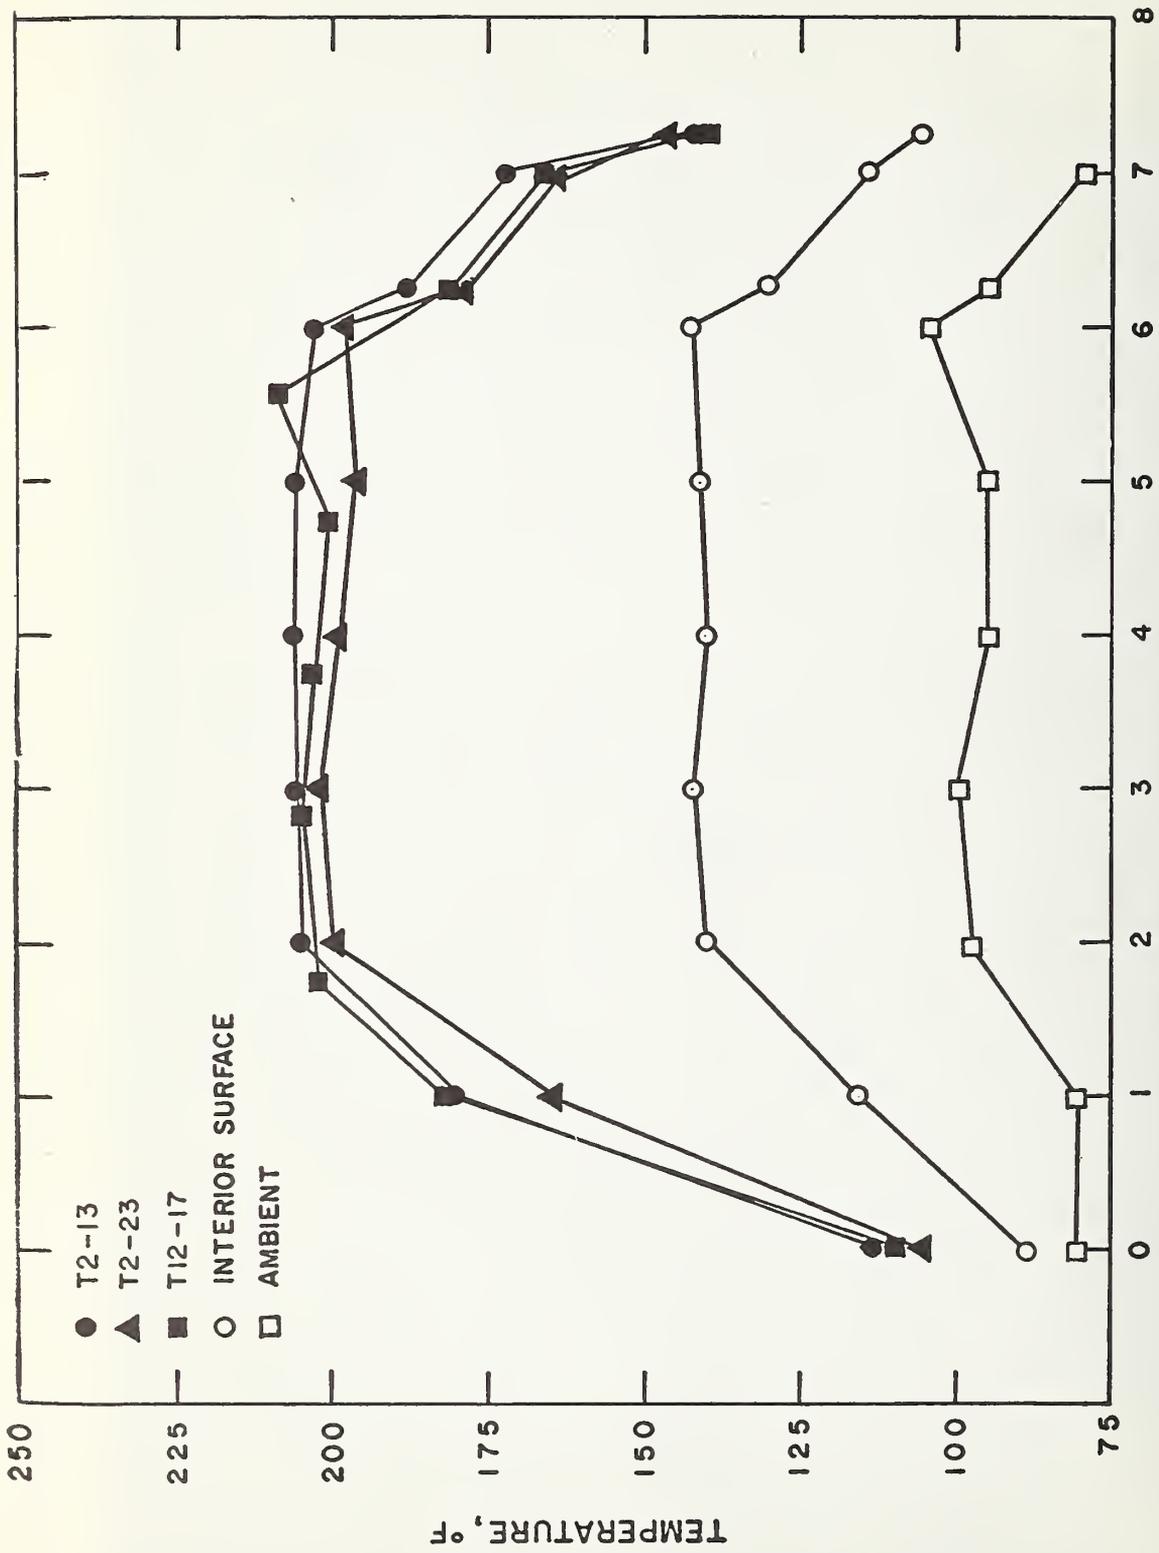
Figure 8 contains a plot of data from three representative exterior surface thermocouples, one interior surface thermocouple, and one ambient air thermocouple during the first cycle of the test. The location of the exterior surface thermocouples can be noted in figure 4. A plot of the thermocouple readings for the second test cycle is not included because of the similarity of readings obtained in the two cycles.

Figure 8. Temperature Readings of Selected Thermocouples During the First Cycle of Shelter Section F-1

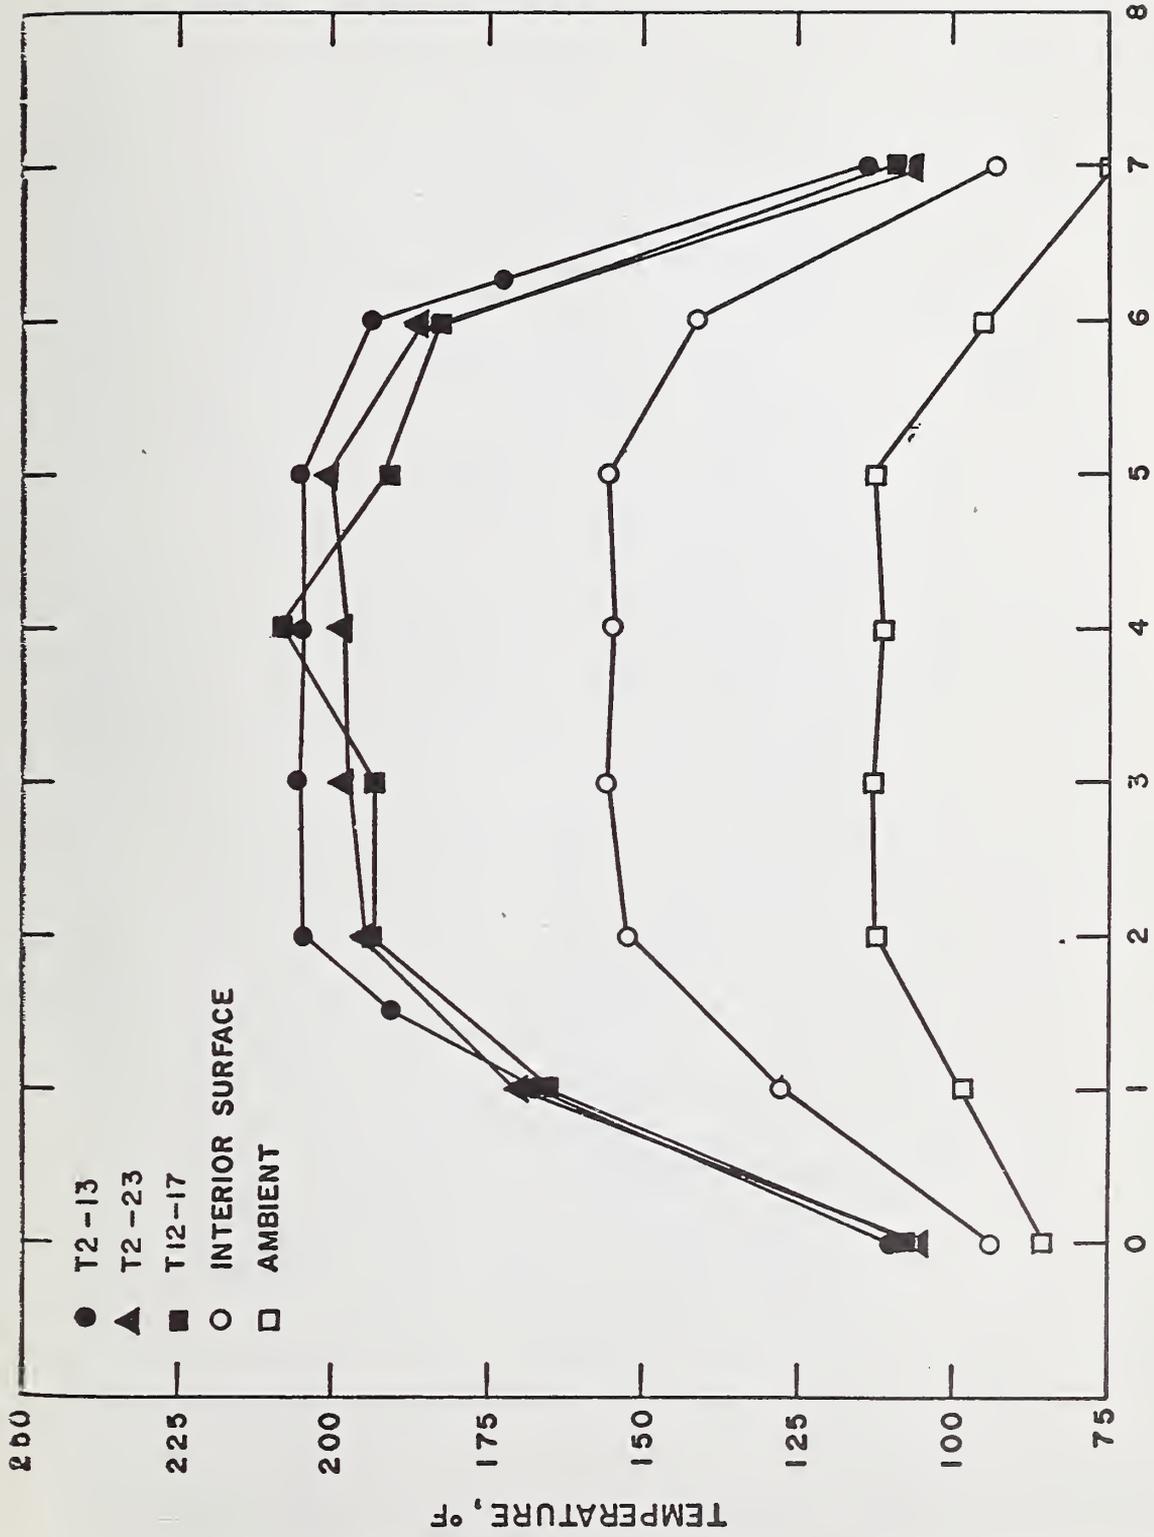
Figure 9 contains a plot of data from three representative exterior surface thermocouples, one interior surface thermocouple, and one ambient air thermocouple during the first cycle of the test. The location of the exterior surface thermocouples can be noted in figure 4. A plot of the thermocouple readings for the second test cycle is not included because of the similarity of the readings obtained in the two cycles.

Figure 9. Temperature Readings of Selected Thermocouples During the First Cycle of Shelter Section F-2

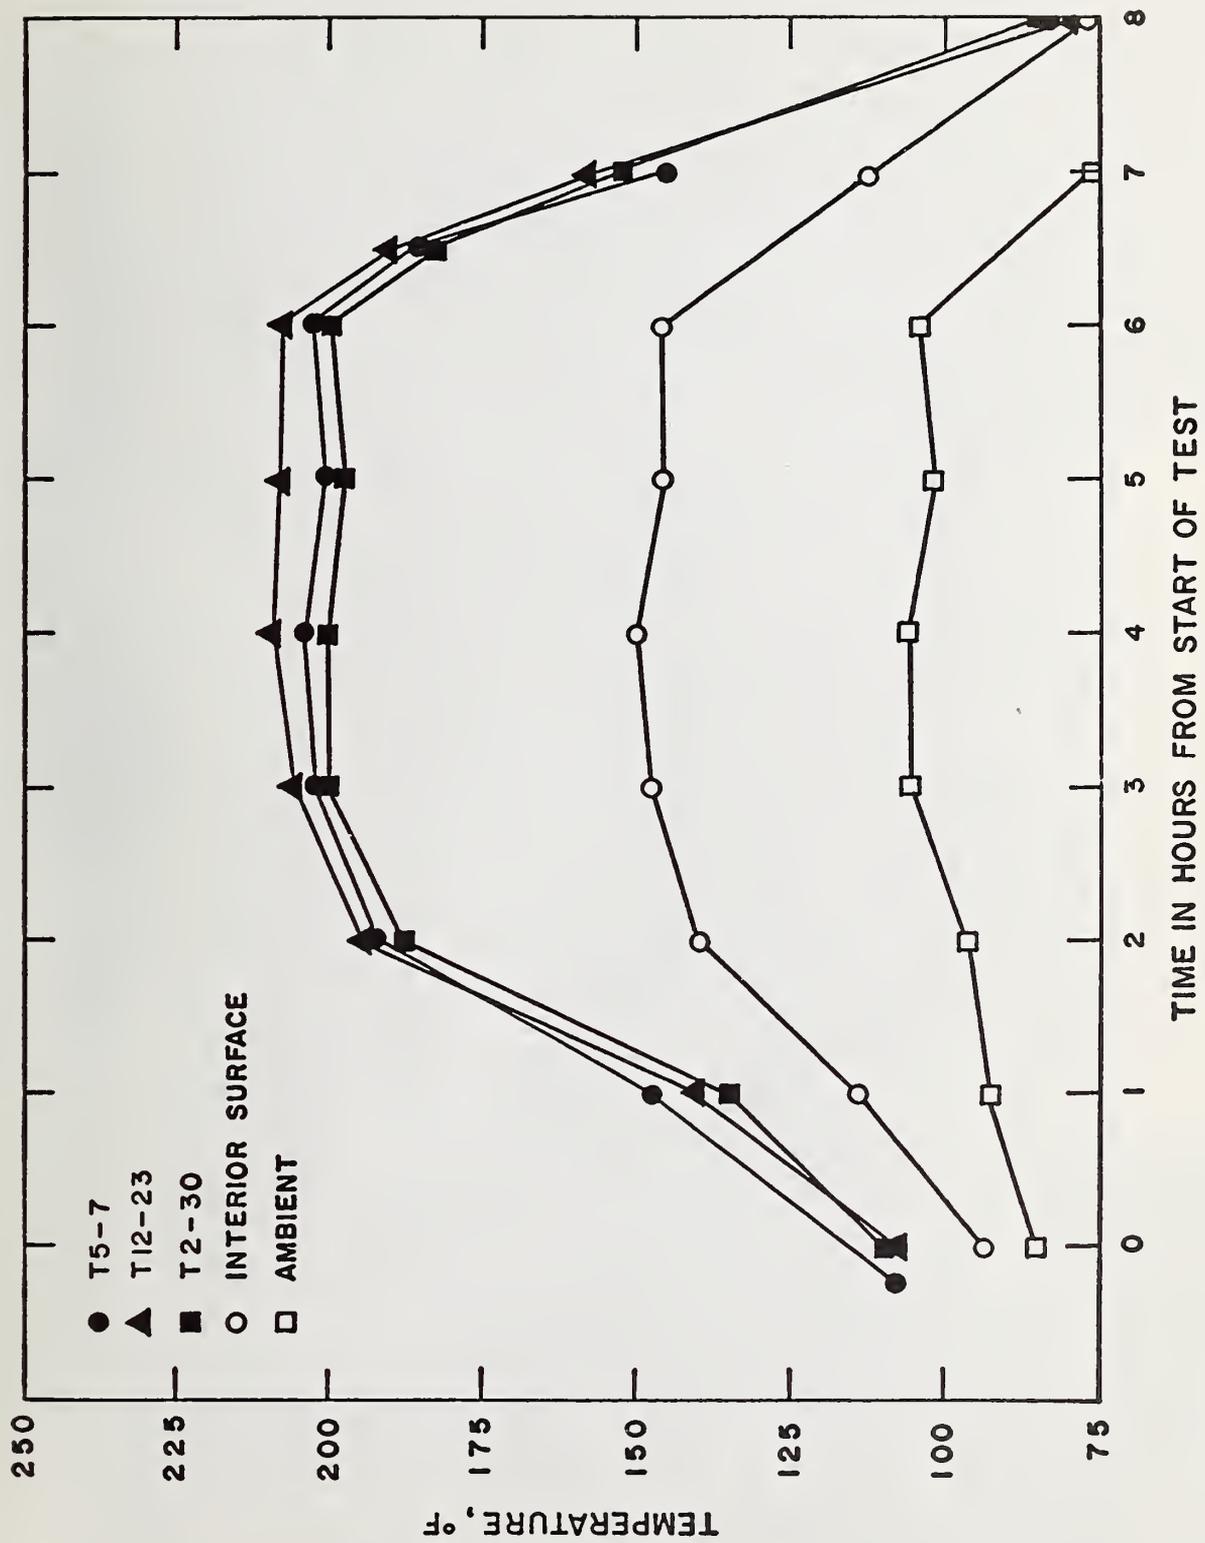
Figure 17 contains a plot of data from three representative exterior surface thermocouples, one interior surface thermocouple, and one ambient air thermocouple during the first cycle of the test. The location of the exterior surface thermocouples can be noted in figure 5.

Figure 17. Temperature Readings of Selected Thermocouples During the First Cycle of Shelter Section IP-1

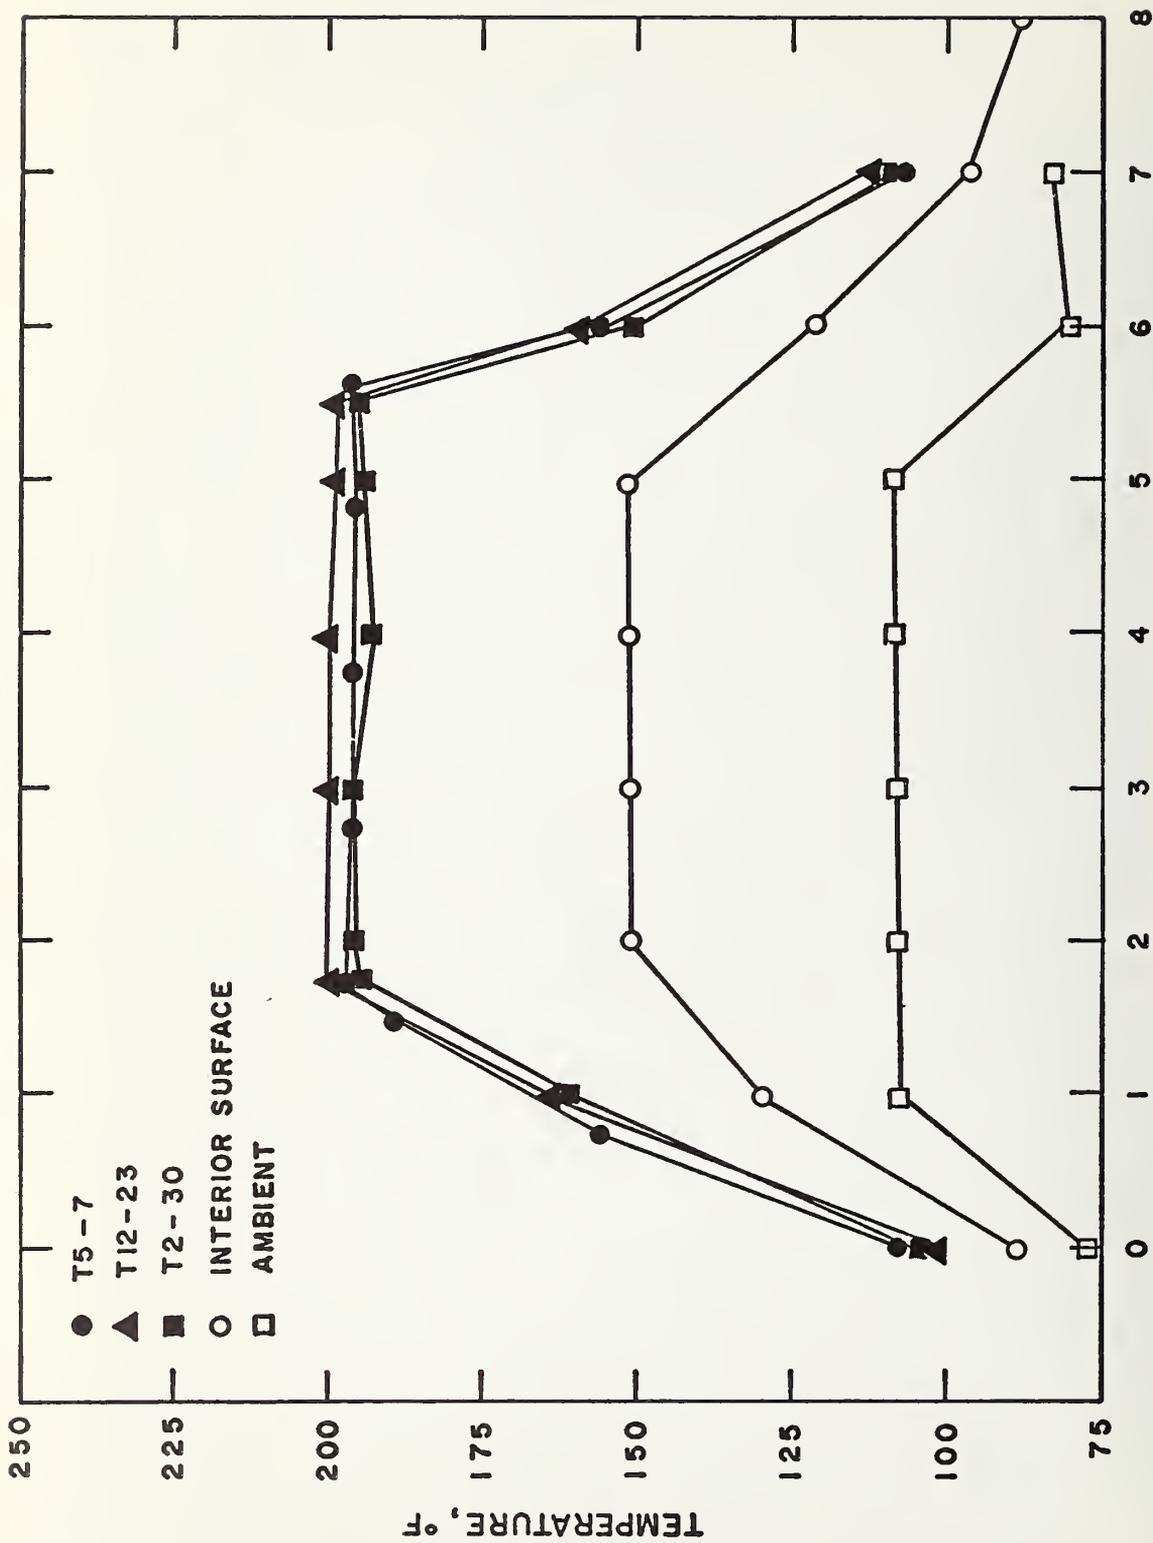
Figure 18 contains a plot of data from three representative exterior surface thermocouples, one interior surface thermocouple, and one ambient air thermocouple during the first cycle of the test. The location of the exterior surface thermocouples can be noted in figure 5.

Figure 18. Temperature Readings of Selected Thermocouples During the First Cycle of Shelter Section IP-2

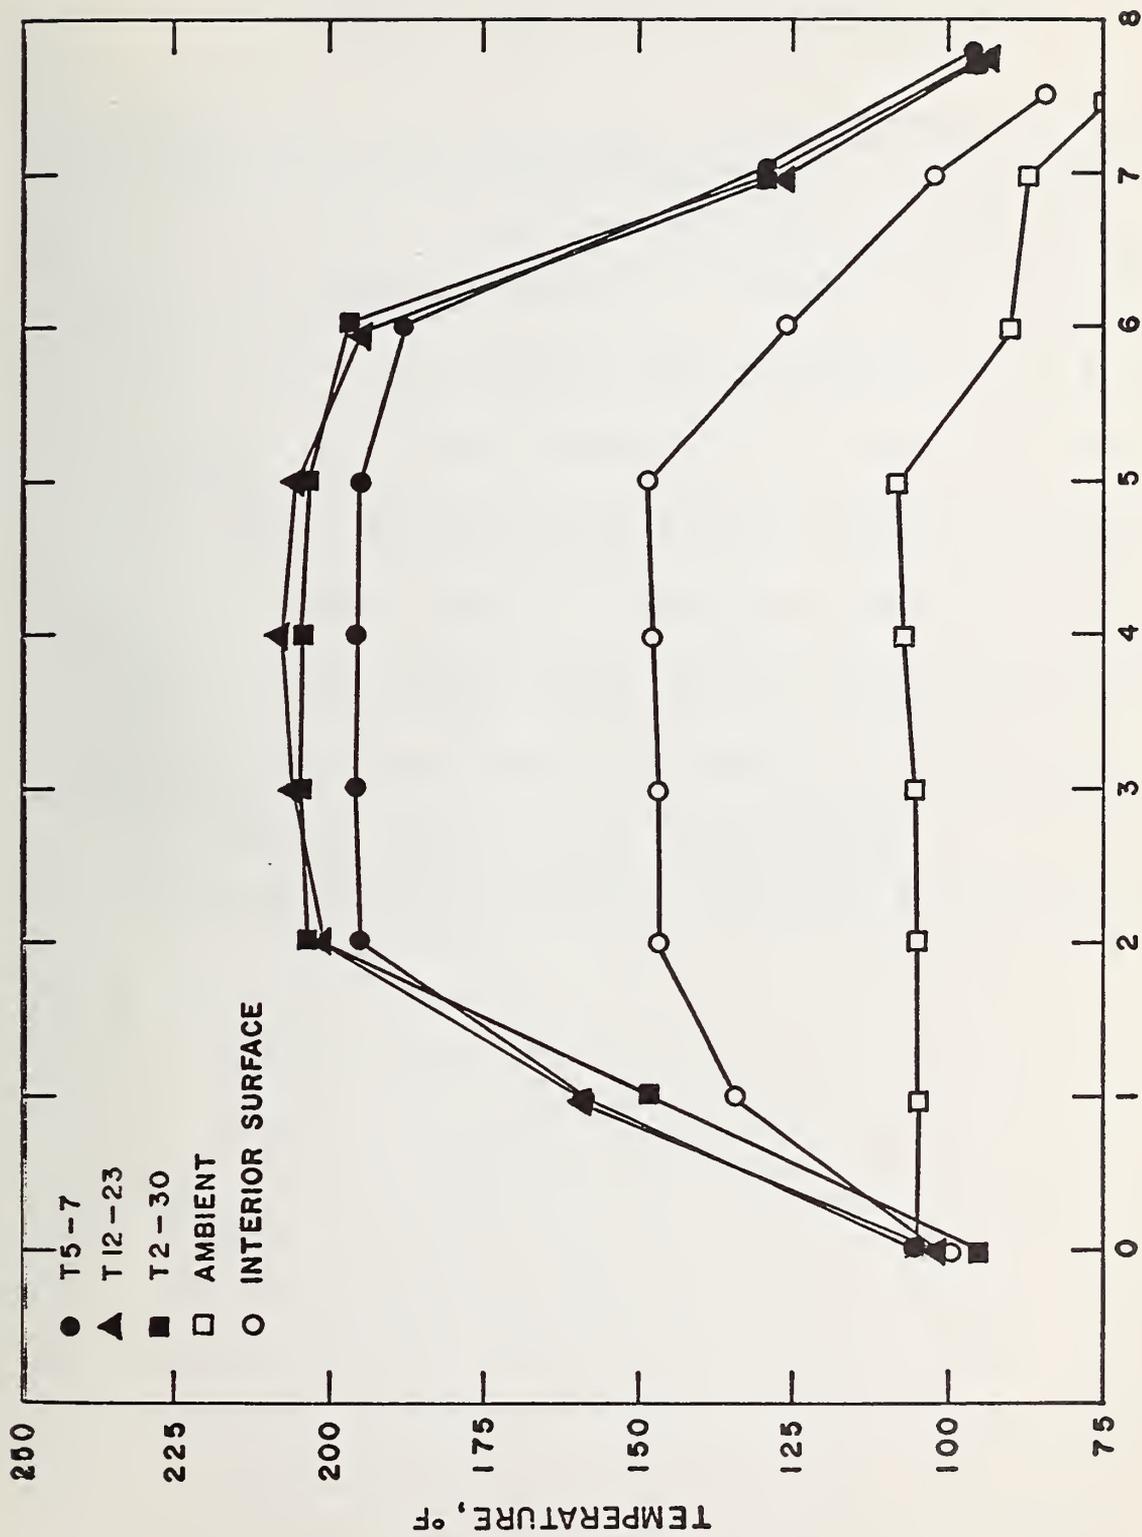
Figure 21 contains a plot of data from three representative exterior surface thermocouples, one interior surface thermocouple, and one ambient air thermocouple during the first cycle of the test. The location of the exterior surface thermocouples can be noted in figure 5.

Figure 21. Temperature Readings of Selected Thermocouples During the First Cycle of Shelter Section IP-3
